FIRE PERFORMANCE EVALUATION OF BPL 1145-1.8, IN ACCORDANCE WITH UNDERWRITERS LABORATORIES (UL) 1715, STANDARD FOR FIRE TEST OF INTERIOR FINISH MATERIAL

SwRI® Project No. 01.13931.01.002b
Test Date: May 23, 2008
Report Date: June 24, 2008

Prepared for:
Burtin Polymer Laboratories
100 Enterprise Drive
Cartersville, GA 30120

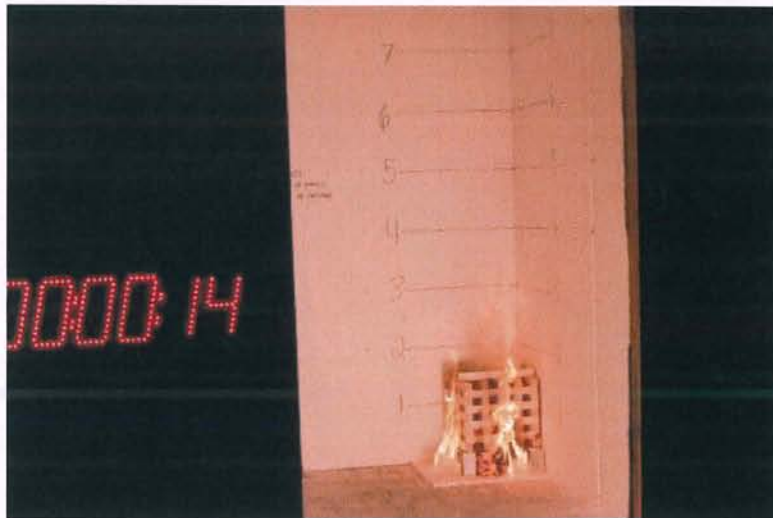
Figure 1. Completed Test Room.

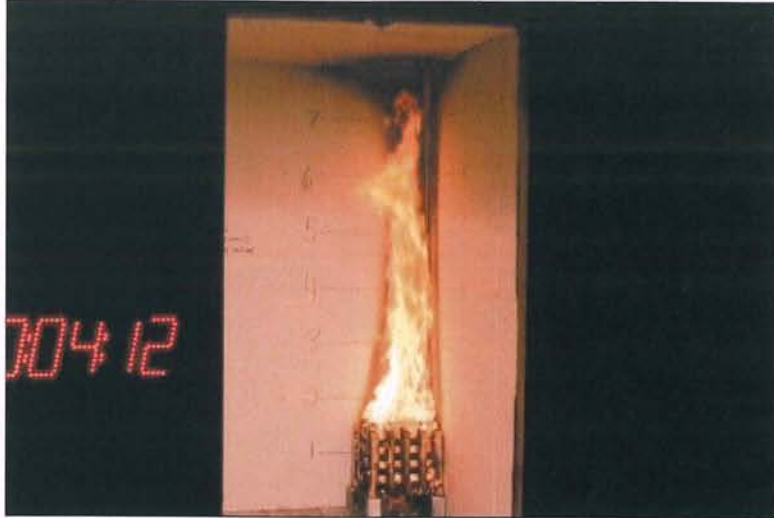
Figure 2. 4 min 12 s into Test.

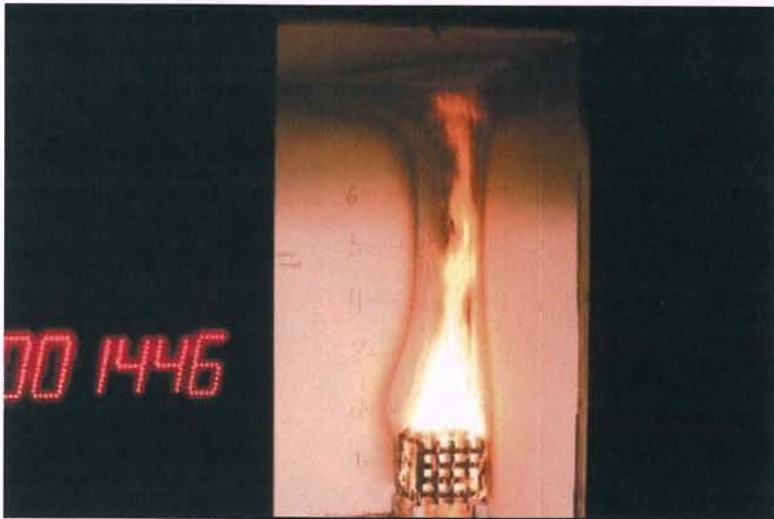
Figure 3. 14 min 46 s into Test.

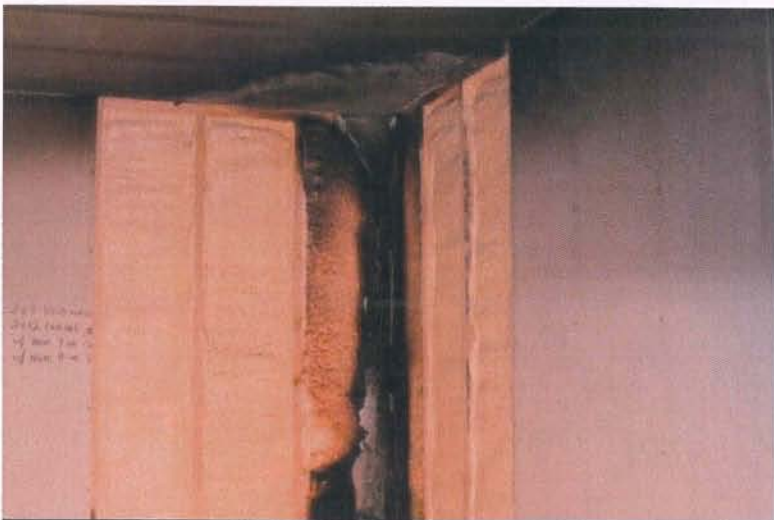
Figure 4. Post-Test: View of Burn Corner with Gypsum Removed.

14:00	No change.
15:00	Crib corner extinguished.
	<p>POST-TEST OBSERVATIONS</p> <p>Upon completion of the test, the gypsum wallboard was removed from the crib corner, revealing discoloration and scorching in the first vertical cavities forming the crib corner.</p>

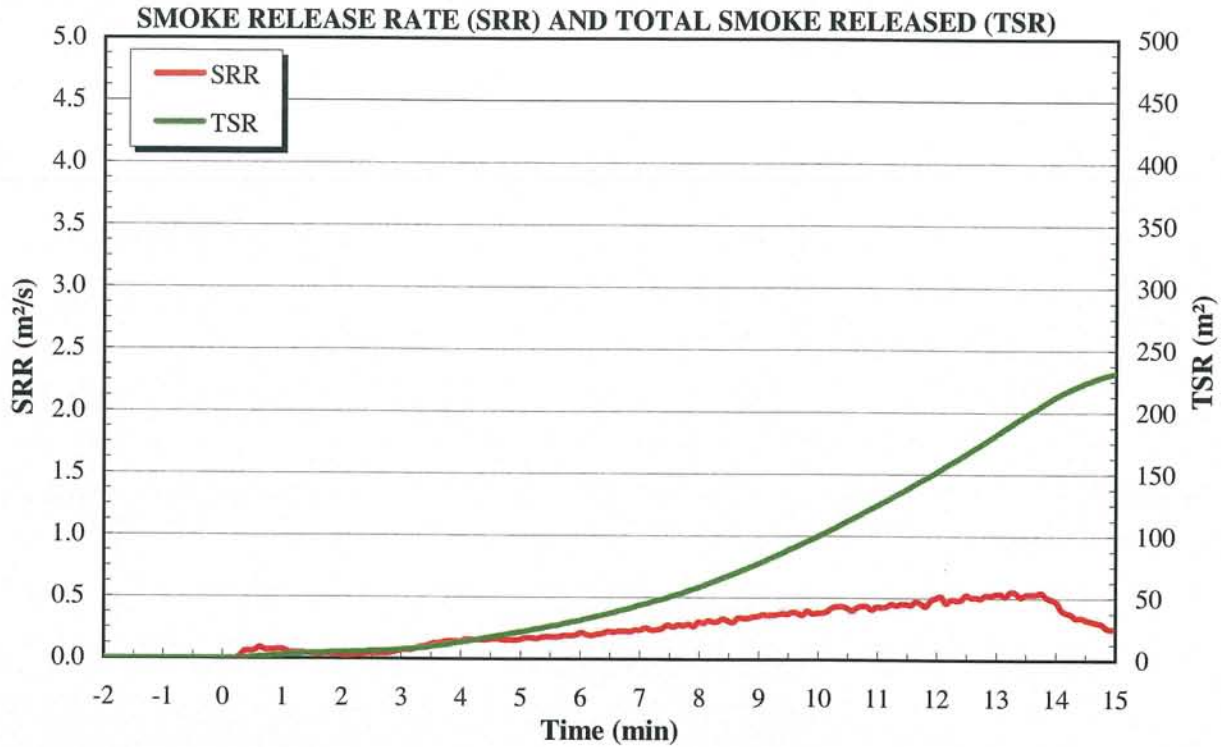
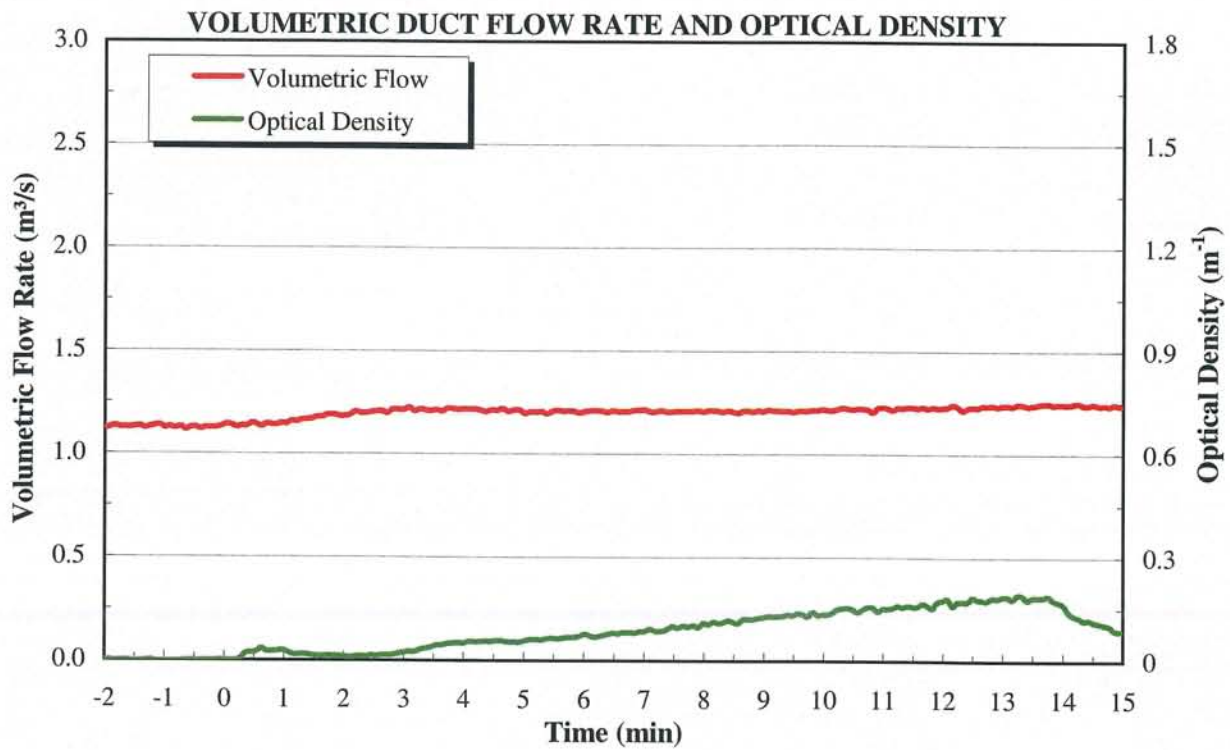
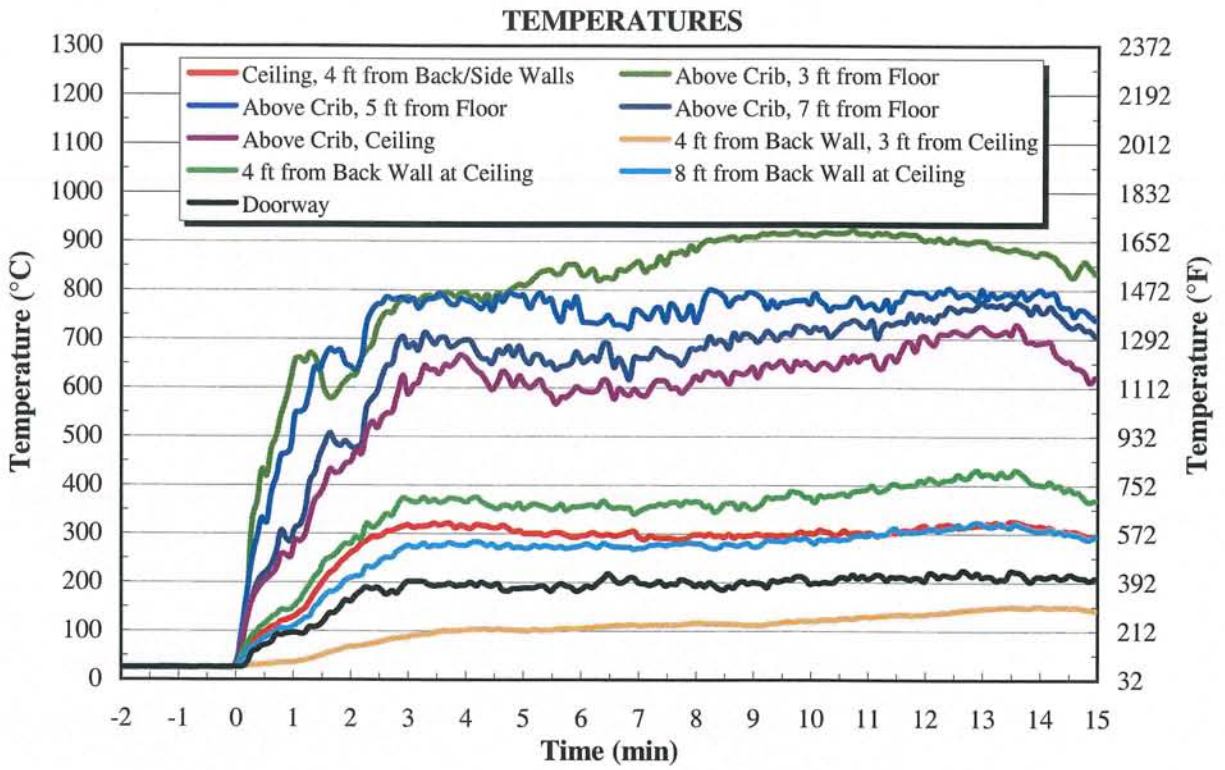
APPENDIX A
TEST DATA
(Consisting of 2 Pages)

The SPF used for testing was selected and inspected by a representative of Technical Assistance Group, Inc. (TAG, Inc.), representing PRI Asphalt Technologies, Inc., on April 14, 2008. The test room and building were at approximately 73 °F and 71% relative humidity, during the test. A summary of the test results is given in Table 2 below. Selected photographic documentation is provided in Figures 1 through 4, and visual observations can be found in Table 3. The test results are summarized in Appendix A.
